Sheet Molded Compound (SMC) Panel Bonding

Document ID# 1655994 2006 Chevrolet Corvette

2000-2018 Chevrolet Corvette Collision Repair Manual

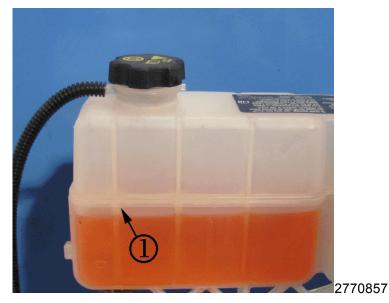
Perform a visual inspection of the drive motor battery cooling system reservoir fluid level BEFORE completing the service repairs in this bulletin.

- If the coolant level of the drive motor cooling system reservoir is below the seam of the reservoir (1), perform leak inspection diagnostics BEFORE proceeding to the service repair in this bulletin. Refer to SI for the appropriate leak inspection diagnostic information. Submit a warranty claim for leak inspection diagnostics and service repairs. After completing the inspection and repairs, proceed to the service repairs in this bulletin.
- If the drive motor cooling system reservoir is **NOT below the seam of the reservoir (1)**, proceed to the service repairs in this bulletin.
