Sheet Molded Compound (SMC) Panel Bonding

Document ID# 1655994 2006 Chevrolet Corvette

2000-2018 Chevrolet Corvette Collision Repair Manual

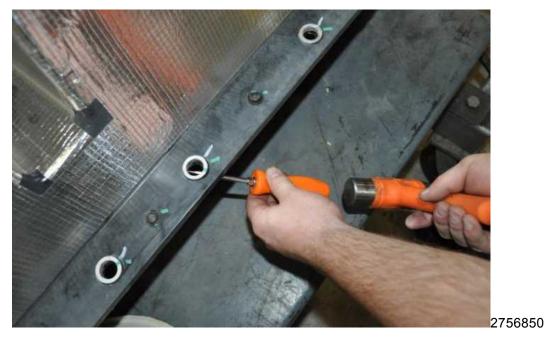
Caution: Do not pry on or contact the battery RESS cover while removing the aluminum crush limiters with screwdriver.

2. Remove the 4th and 5th aluminum crush limiters (indicated with red arrows in illustration) from the driver's and passenger's side of the battery RESS cover.

- 2.1 Place the tip of a small flat-blade screwdriver against the bottom of each aluminum crush limiter. Access the bottom of the crush limiter through the hole on the bottom side of the battery RESS cover.
- 2.2 Gently tap the end of the screwdriver with a small hammer. You may have to work around the bottom of the aluminum crush limiter, tapping it in a few locations to completely free the aluminum crush limiter from the cover.

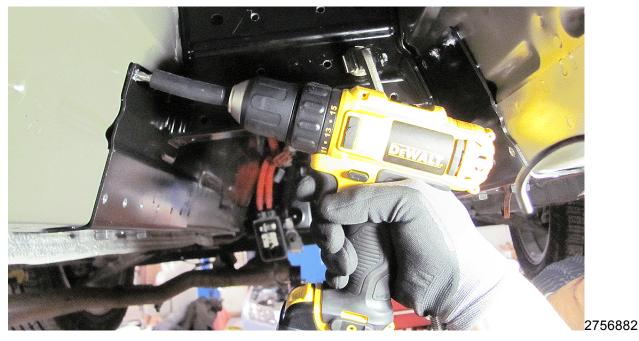
Caution: To avoid vehicle damage, place a drill stop on drill bits to ensure drill does NOT enter the vehicle beyond 19 mm ($\frac{3}{4}$ in) in depth.

Drill 3mm (1/8 in) pilot holes into the vehicle body through the 28 existing holes in the reinforcement assembly. Do not allow the drill bit to enter the vehicle body beyond 19 mm (³/₄ in) in depth for the six upper holes on each side.

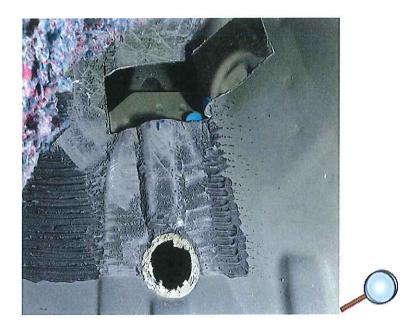
This condition may be caused by an insufficiently tightened cradle mount bolt or two out of position spot welds within the front right frame rail.

16. Bend the tab back revealing the two spot welds as shown.
